Site Inspection Report

Moran Court, Beaconsfield 6162

Lot:	Moran Court, Beaconsfield 6162	Job No.:	12365
Client Name:	Jenny Way	Date:	2 Aug 2017

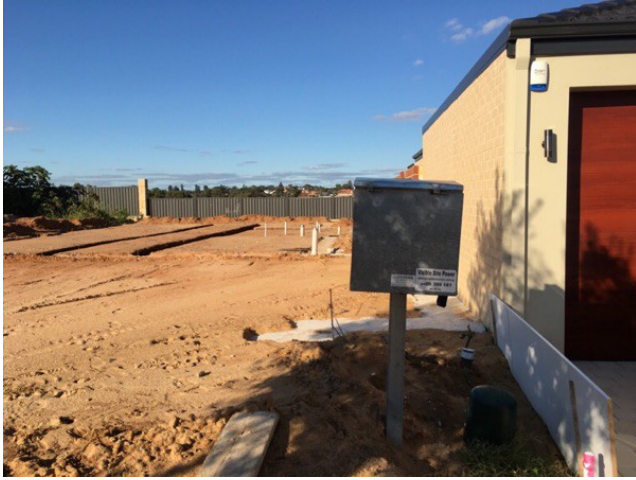
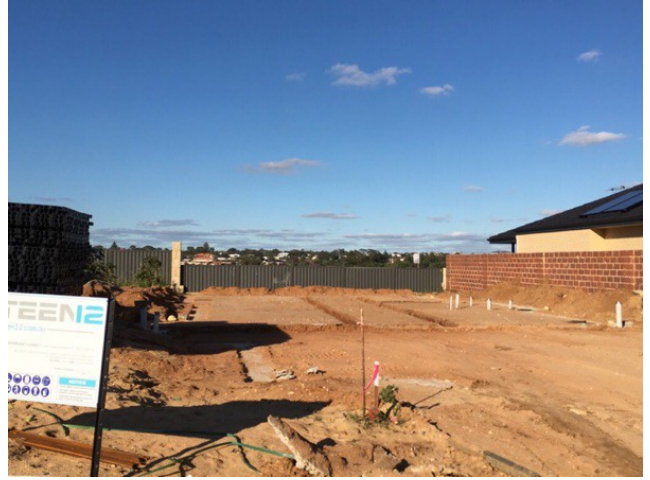
Safety Issues - Overhead power cables
Taken : 03/08/2017

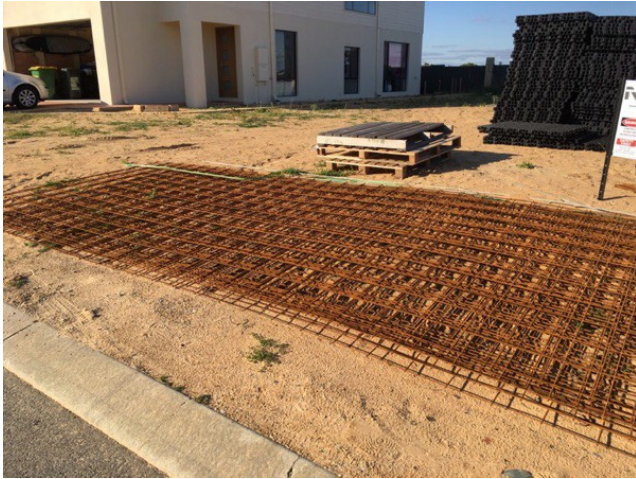
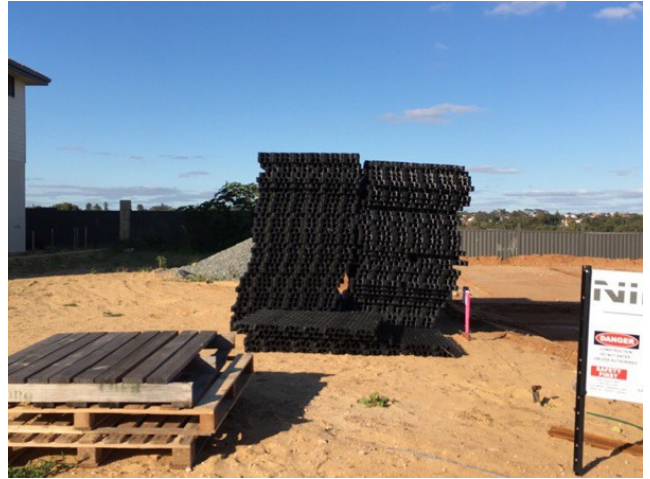
Safety Issues - Possible public liability
Taken : 03/08/2017

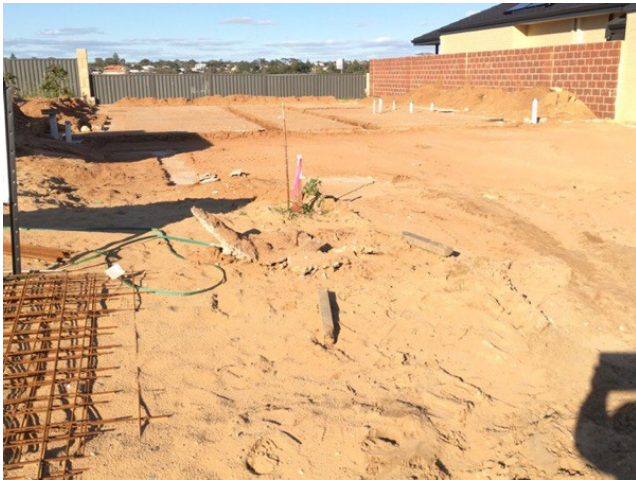
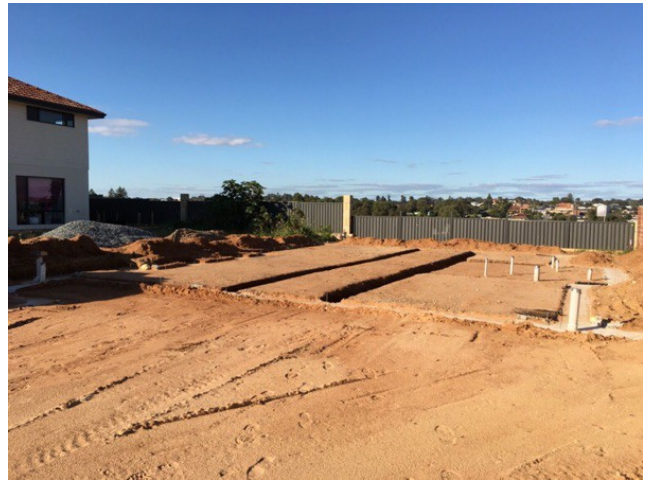
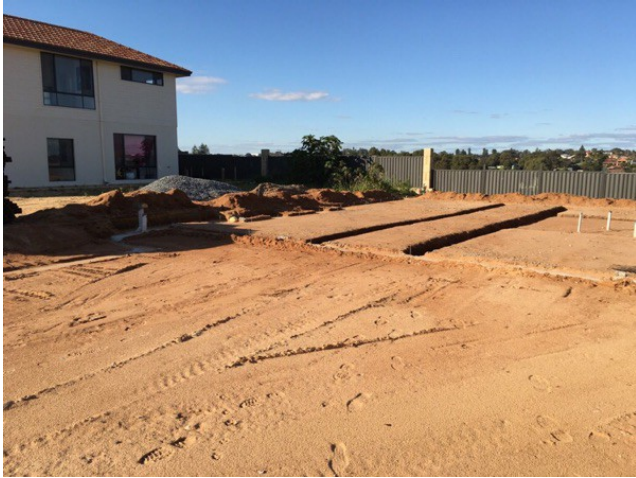
Fences/Retaining
Taken : 03/08/2017

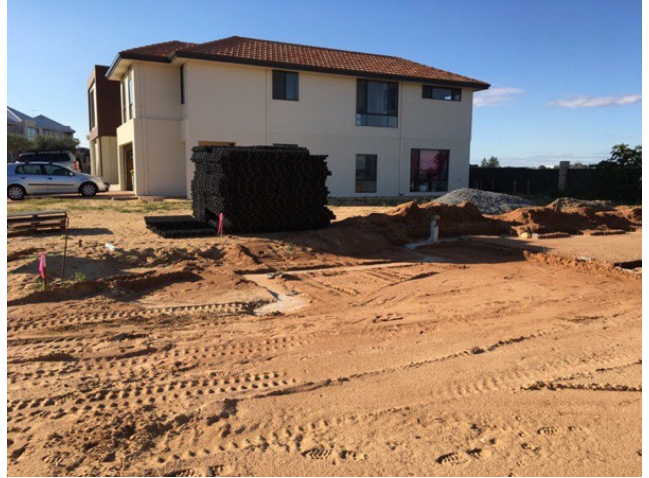
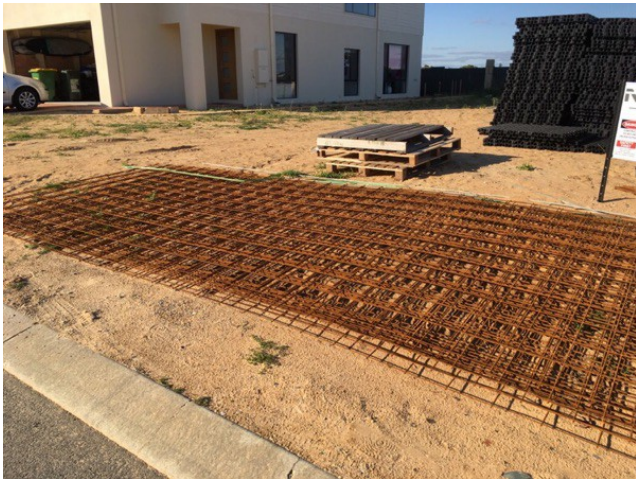
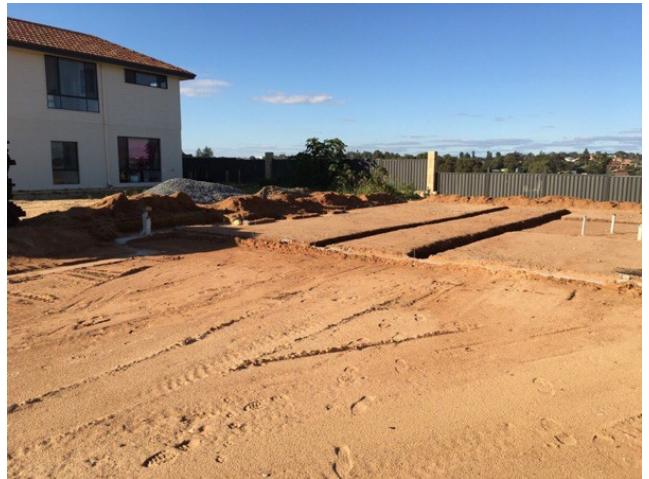
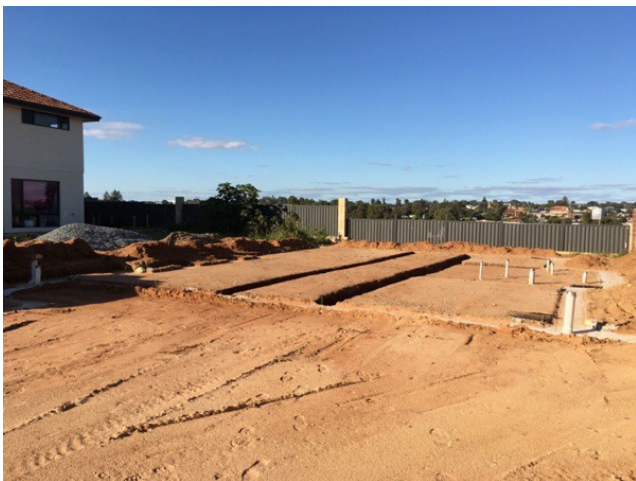
Fences/Retaining - Existing fence to left
Taken : 03/08/2017

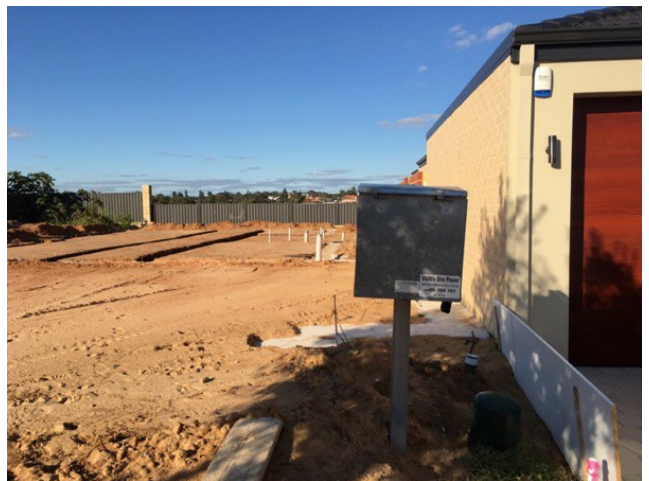
Fences/Retaining - Existing fence to right
Taken : 03/08/2017

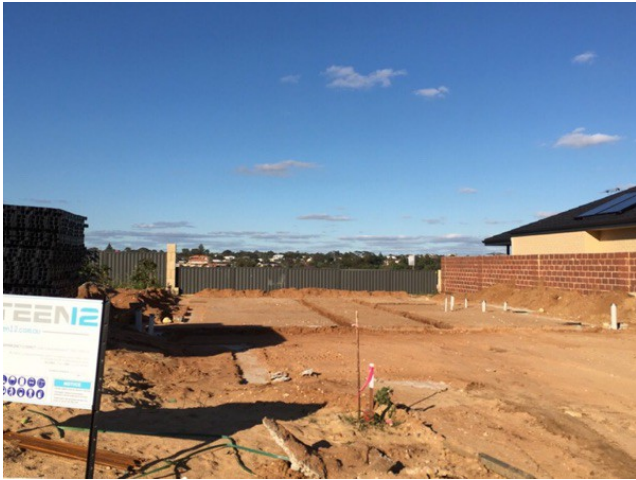
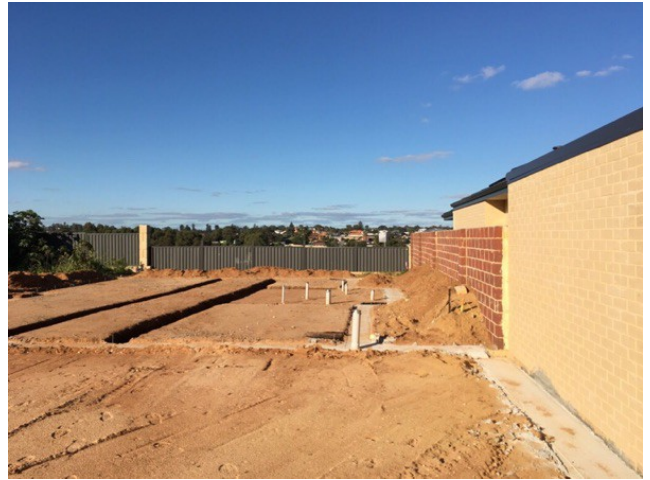
Fences/Retaining - Existing fence to rear
Taken : 03/08/2017

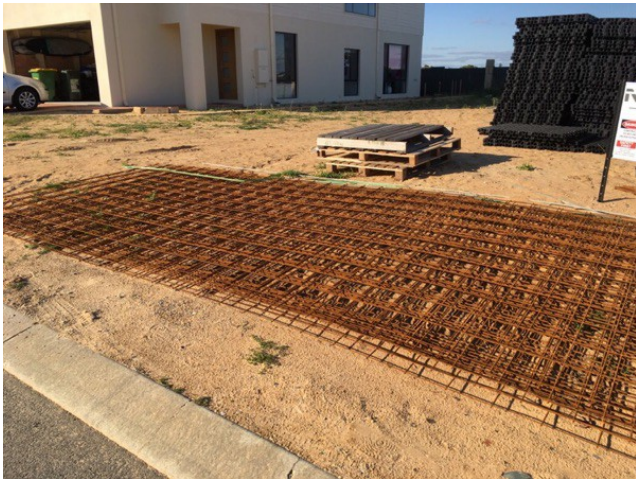
Area	Yes/No	Comments
3 - Site Access	Yes	Good - however noted that the verge is being used for parking by next door. May become an issue.
Vegetation removal required	No	
Kerb cracked	No	
Kerb mountable	Yes	
Footpath cracked	No	No footpath laid yet
Footpath mountable	No	No footpath laid yet
Suitable site access	Yes	
Limestone access track required	No	
Traffic Management required	Yes	
Access track required	No

Site Access - Kerb mountable
Taken : 03/08/2017

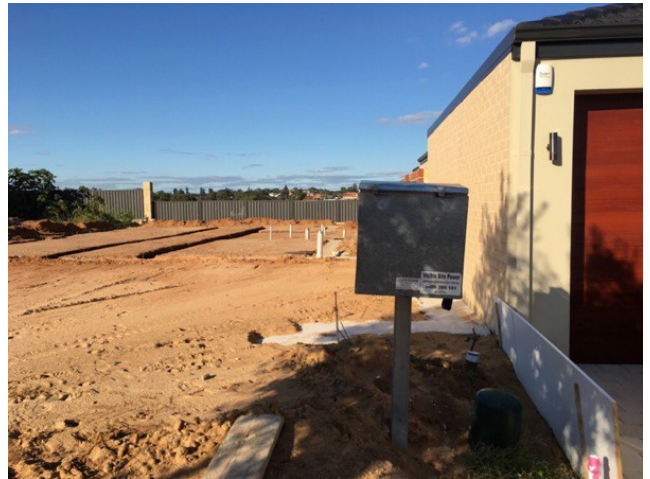
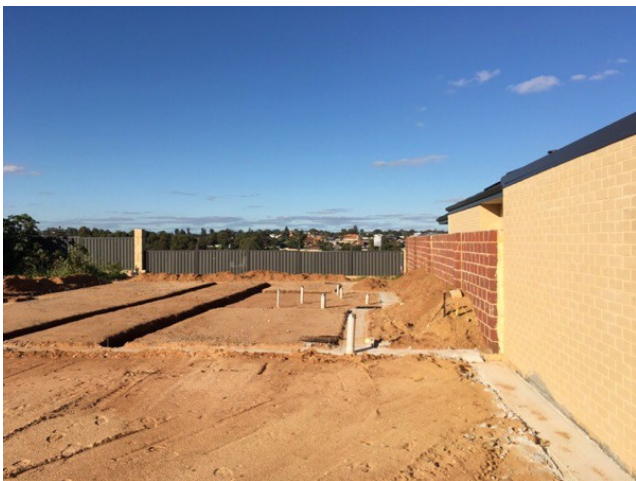
Services/Utility
Taken : 03/08/2017

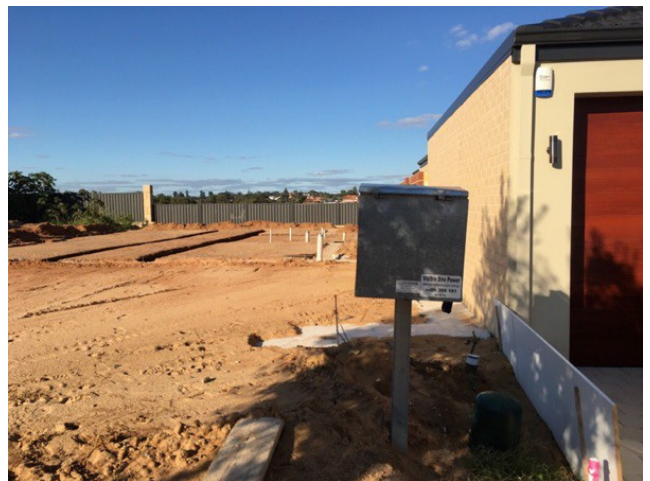
Services/Utility - Power
Taken : 03/08/2017
