Site Inspection Report

Moran Court, Beaconfield 6162

Lot	Moran Court, Beaconfield 6162
Client Name	Jenny Way
Job No.	12365
Date	16 Sep 2019

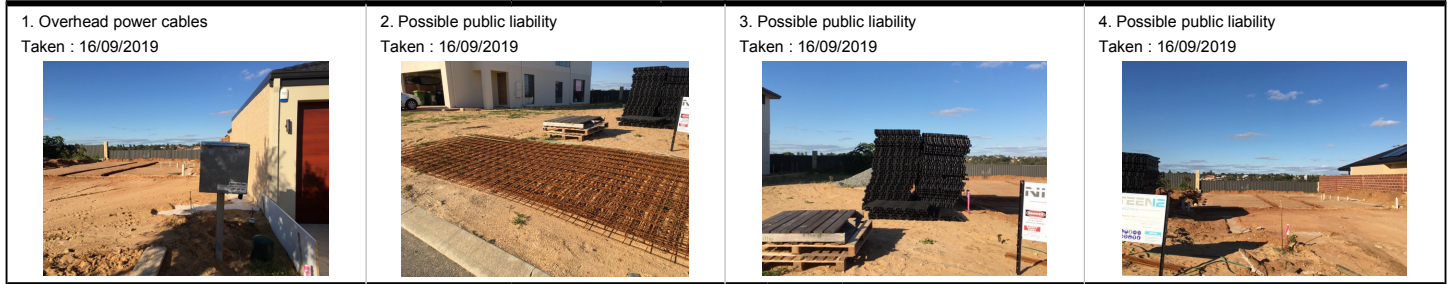
Area	Yes/No	Comments
1 - Safety Issues	Yes	
Overhead power cables	No	No problems - underground power connected to the site.
Possible public liability	Yes	Material being stored on adjacent site. Site generally open with unsecured material that could pose a hazard.
Asbestos onsite	No	
Safety rail required	Yes	Will need safety rail when construction commences. Will check on next visit.

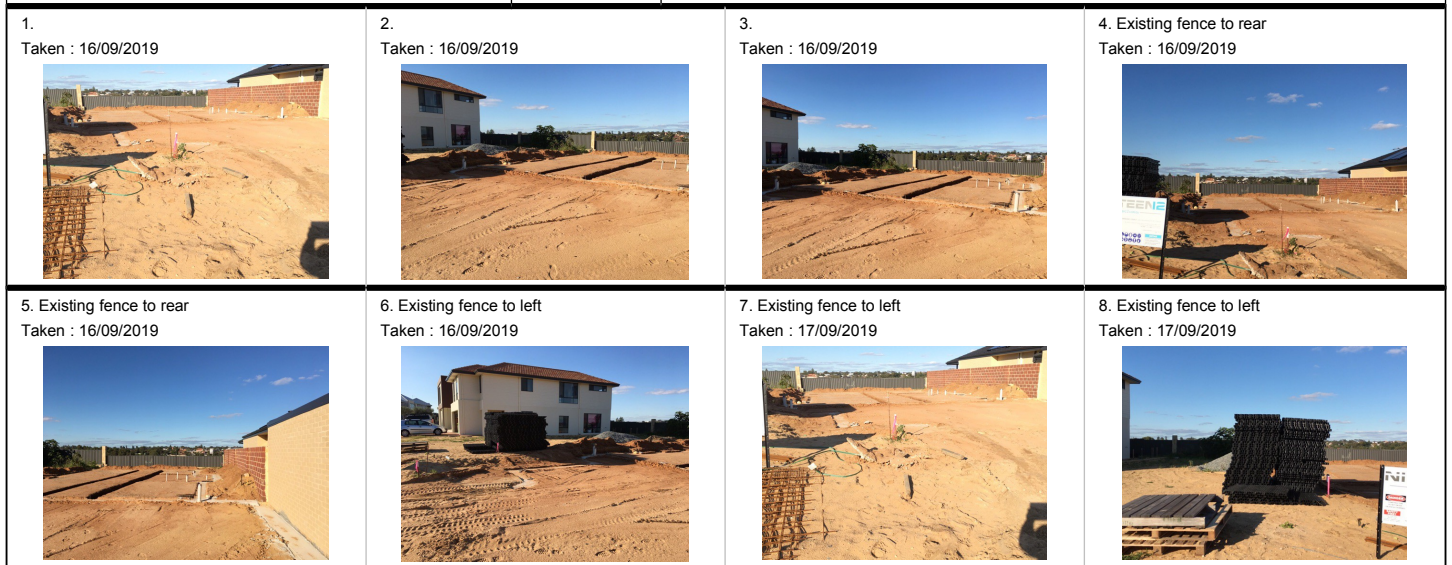
Area	Yes/No	Comments
2 - Fences/Retaining	Yes	Recommend the site is secured as adjoining block is POS.
Existing fence to front	No	
Existing fence to left	No	Recommend this Boundry is secured
Existing fence to right	Yes	
Existing fence to rear	Yes	
Existing retaining walls	No	Not required
Additional retaining required	Yes	Possibly at rear of property. Recommend Inspection.
Chemical injection required	No	Not at this stage
Undermining concerns	No	
Dilapidation Report required	Yes
