Site Inspection Report

Moran Court, Beaconsfield 6162

Lot:	Moran Court, Beaconsfield 6162	Job No.:	12365
Client Name:	Jenny Way	Date:	2 Aug 2017

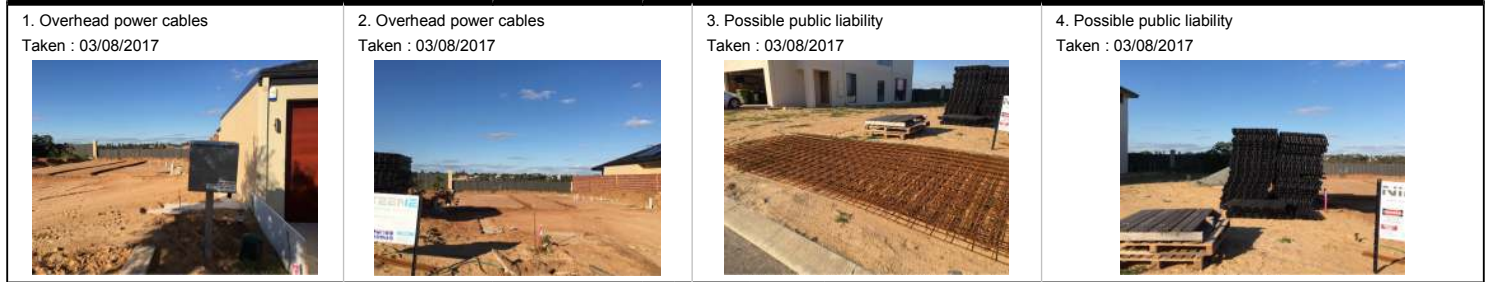
Area	Yes/No	Comments
1 - Safety Issues	Yes	
Overhead power cables	No	No problems - underground power connected to the site.
Possible public liability	Yes	Material being stored on adjoining site. Site generally open with unsecured materials that could pose a hazard.
Asbestos onsite	No	
Safety rail required	Yes	Will need safety rail when construction commences. Will check on next visit.

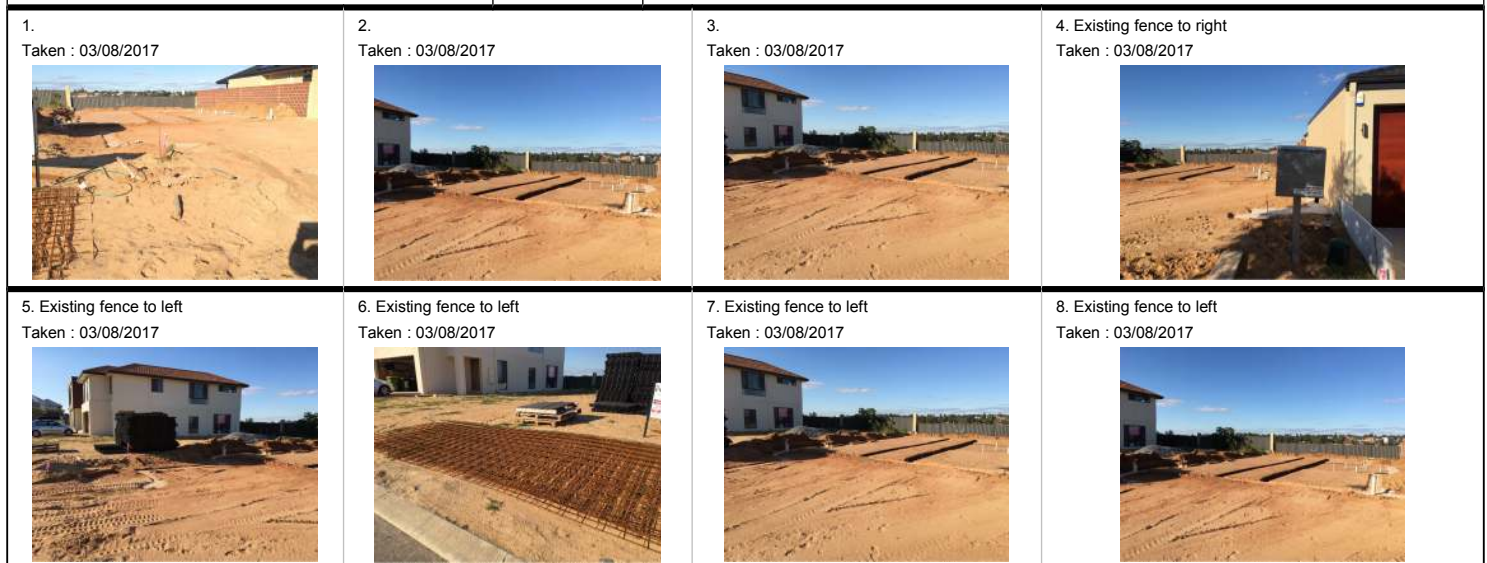
Area	Yes/No	Comments
2 - Fences/Retaining	Yes	Recommend site is secured as adjoining block is POS.
Existing fence to front	No	
Existing fence to left	No	Recommend this boundary is secured
Existing fence to right	Yes	
Existing fence to rear	Yes	
Existing retaining walls	No	Not required
Additional retaining required	Yes	Possibly at rear of property. Recommend Inspection.
Chemical injection required	No	Not at this stage
Undermining concerns	No	
Dilapidation Report required	Yes

<p>9. Existing fence to rear Taken : 03/08/2017</p>  	<p>10. Existing fence to rear Taken : 03/08/2017</p>  		
--	--	--	--
